Pitch torque tube end cap - replacement

| Classification - | Mandatory |
| Applicability | All Europa aircraft |

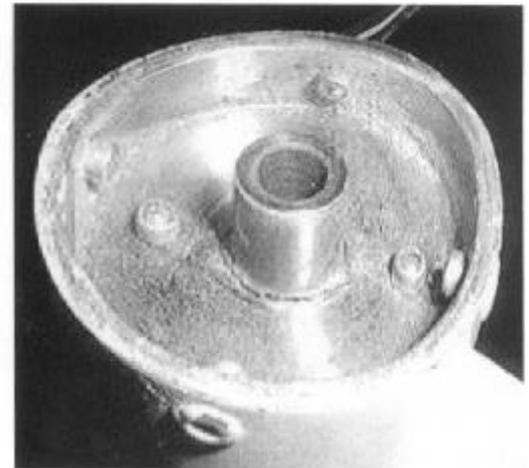
Two cases have been found of cracking occurring in the pitch torque tube end cap (part no. CS10C), see the photo in figure 1.

The cracks occurred at the base of the bolt hole boss. A crack at this position can result in fore and aft movement of the pitch torque tube under load, causing movement of the tailplane relative to the control column position. It is then theoretically possible for there to be less than the minimum required movement of the tailplane resulting in degraded elevator authority.
